STAPLETON INTERNATIONAL
AIRPORT

★
GROUND WATER
MONITORING

★
SOUTHERN TIER OF
ROCKY MOUNTAIN ARSENAL

February 1987

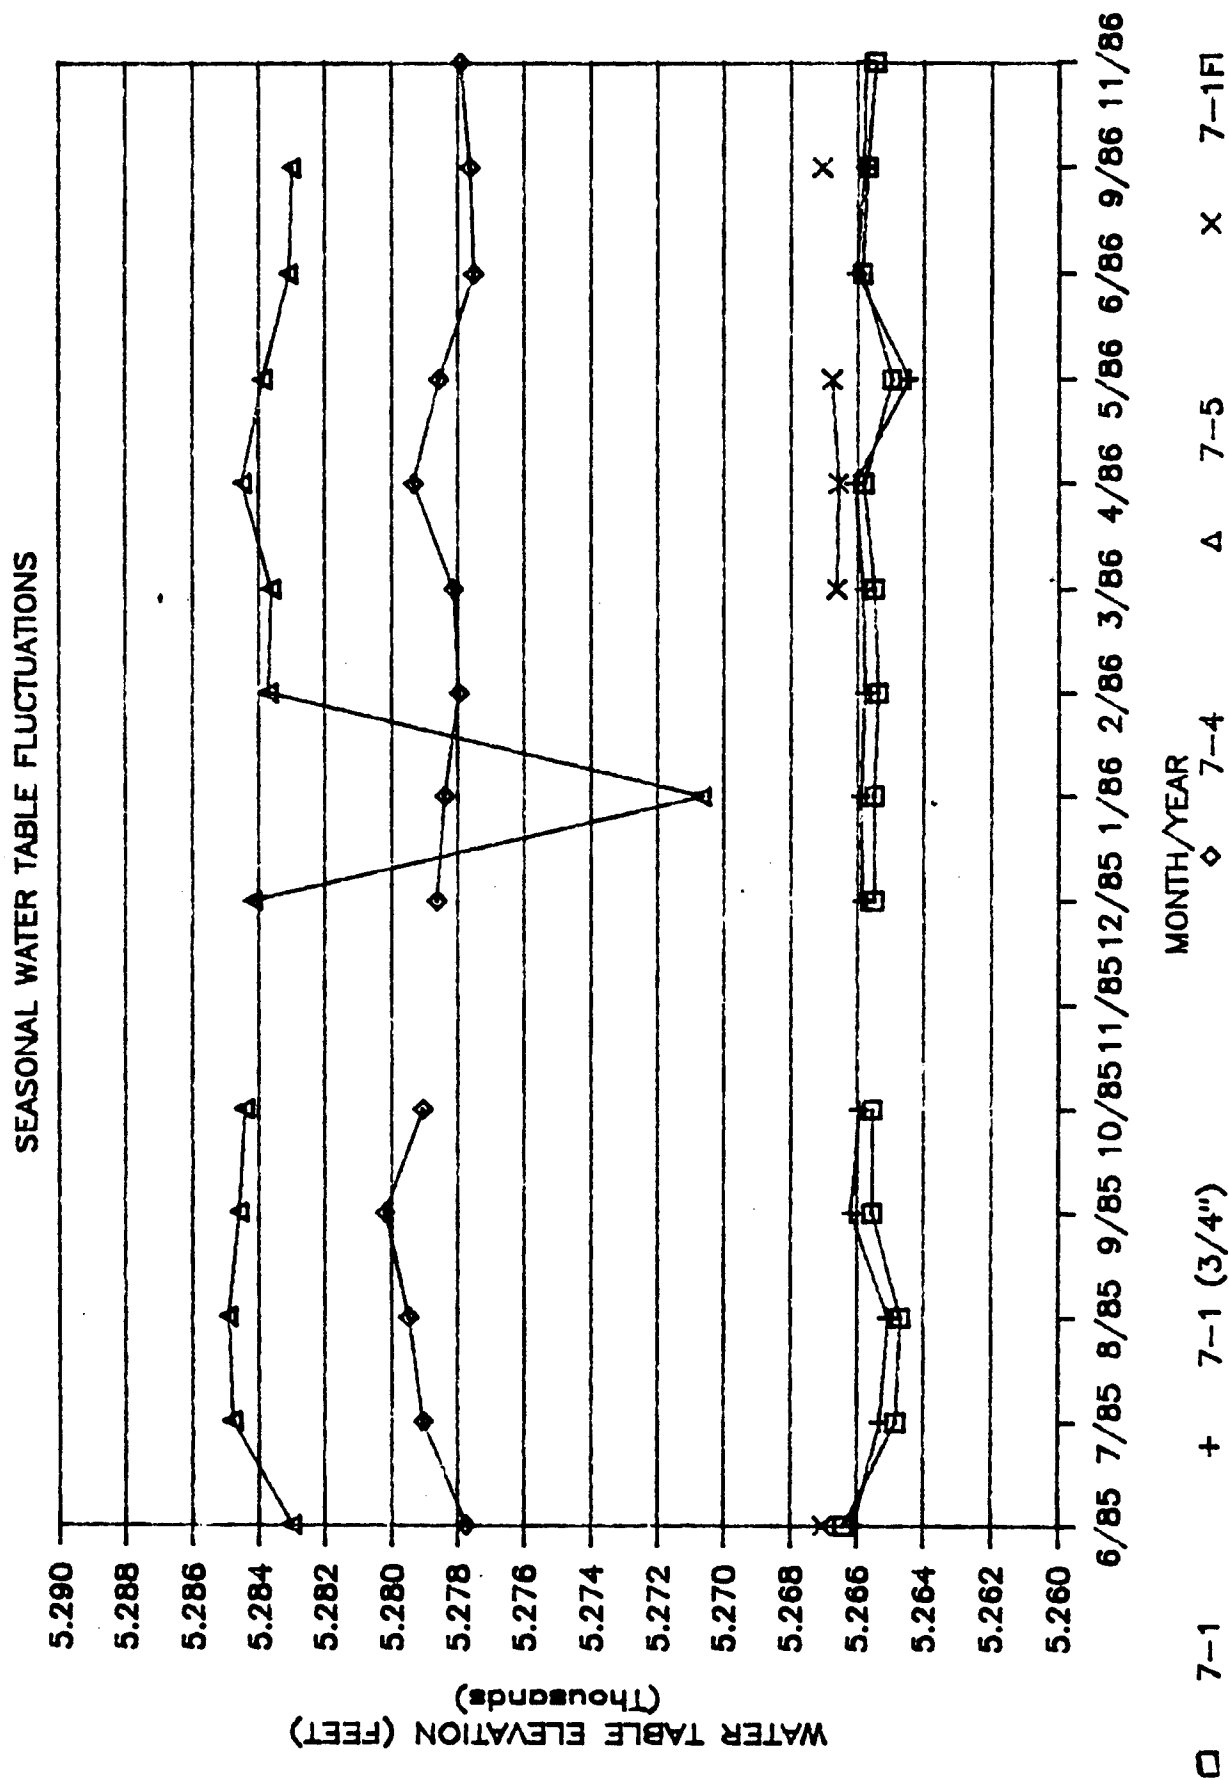
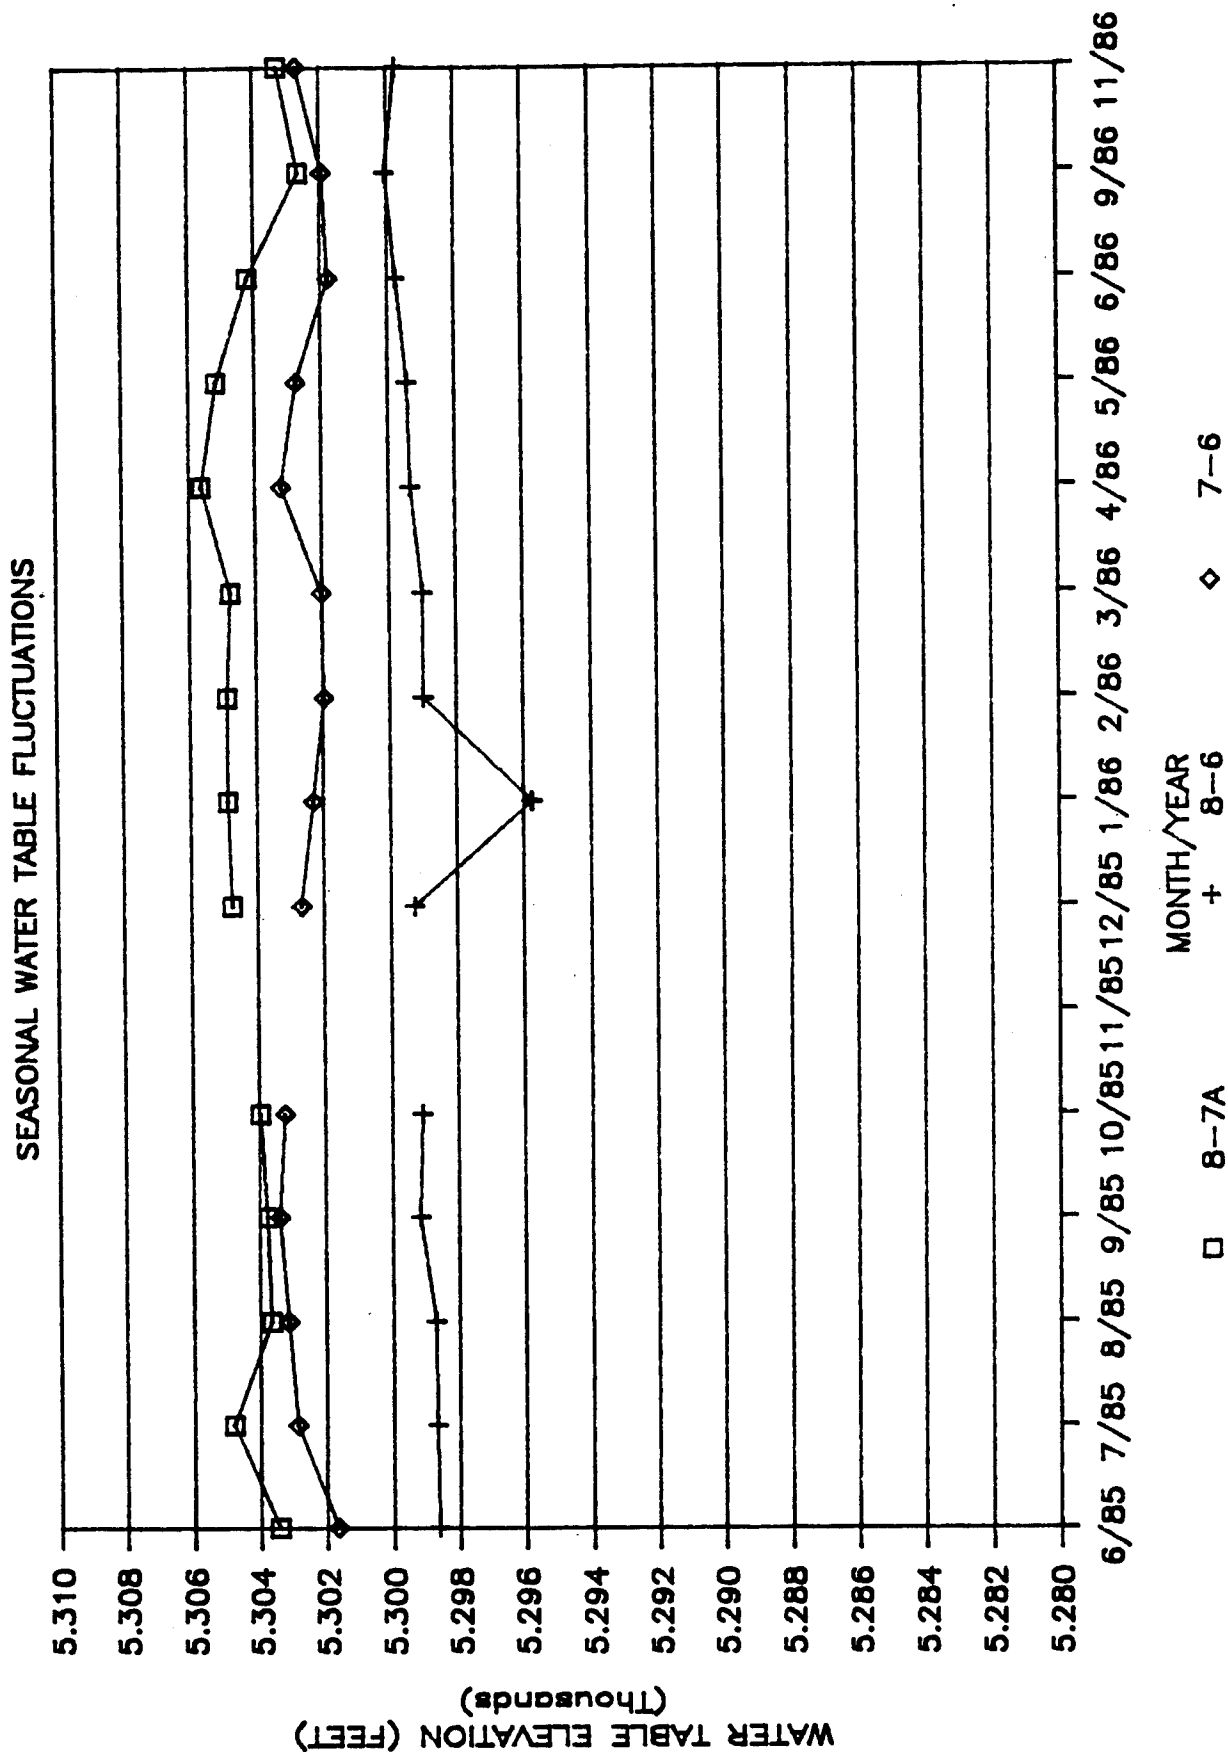
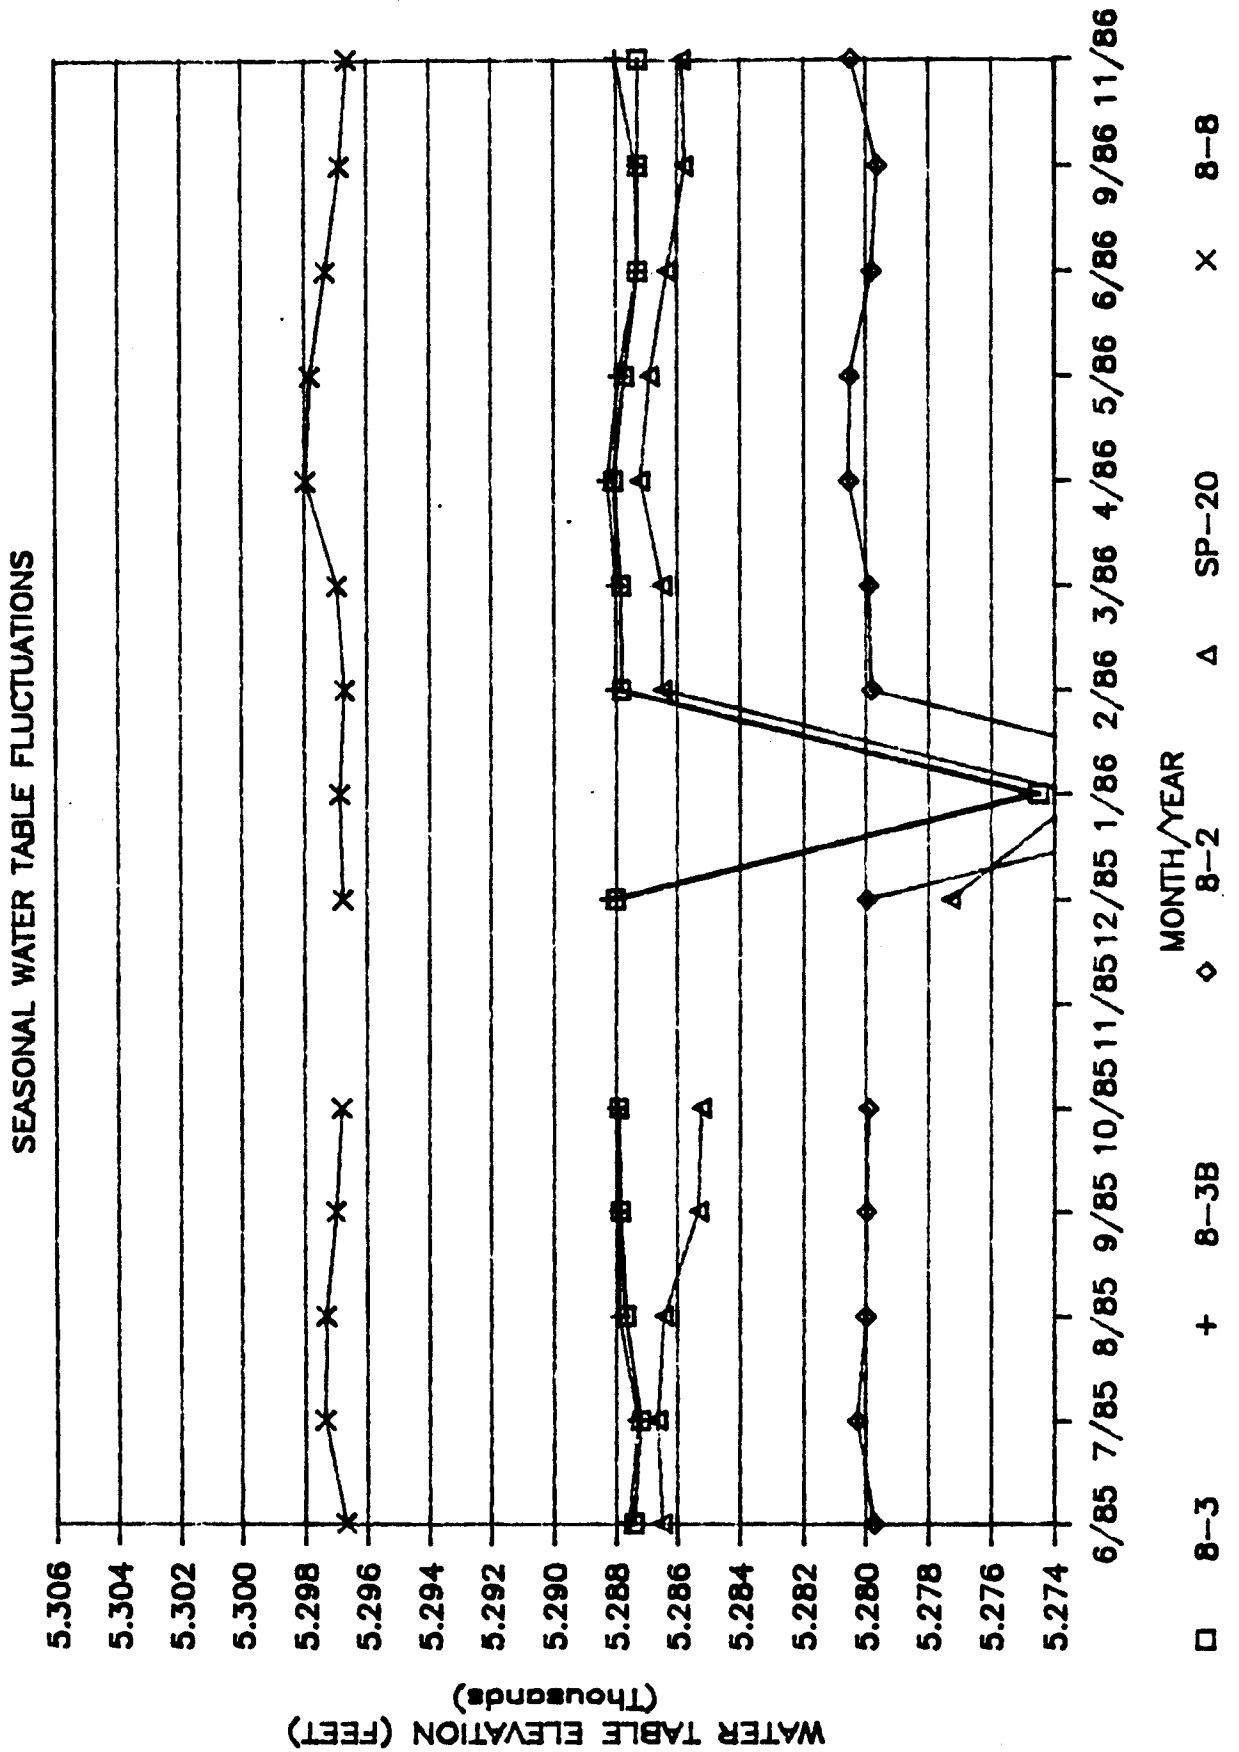
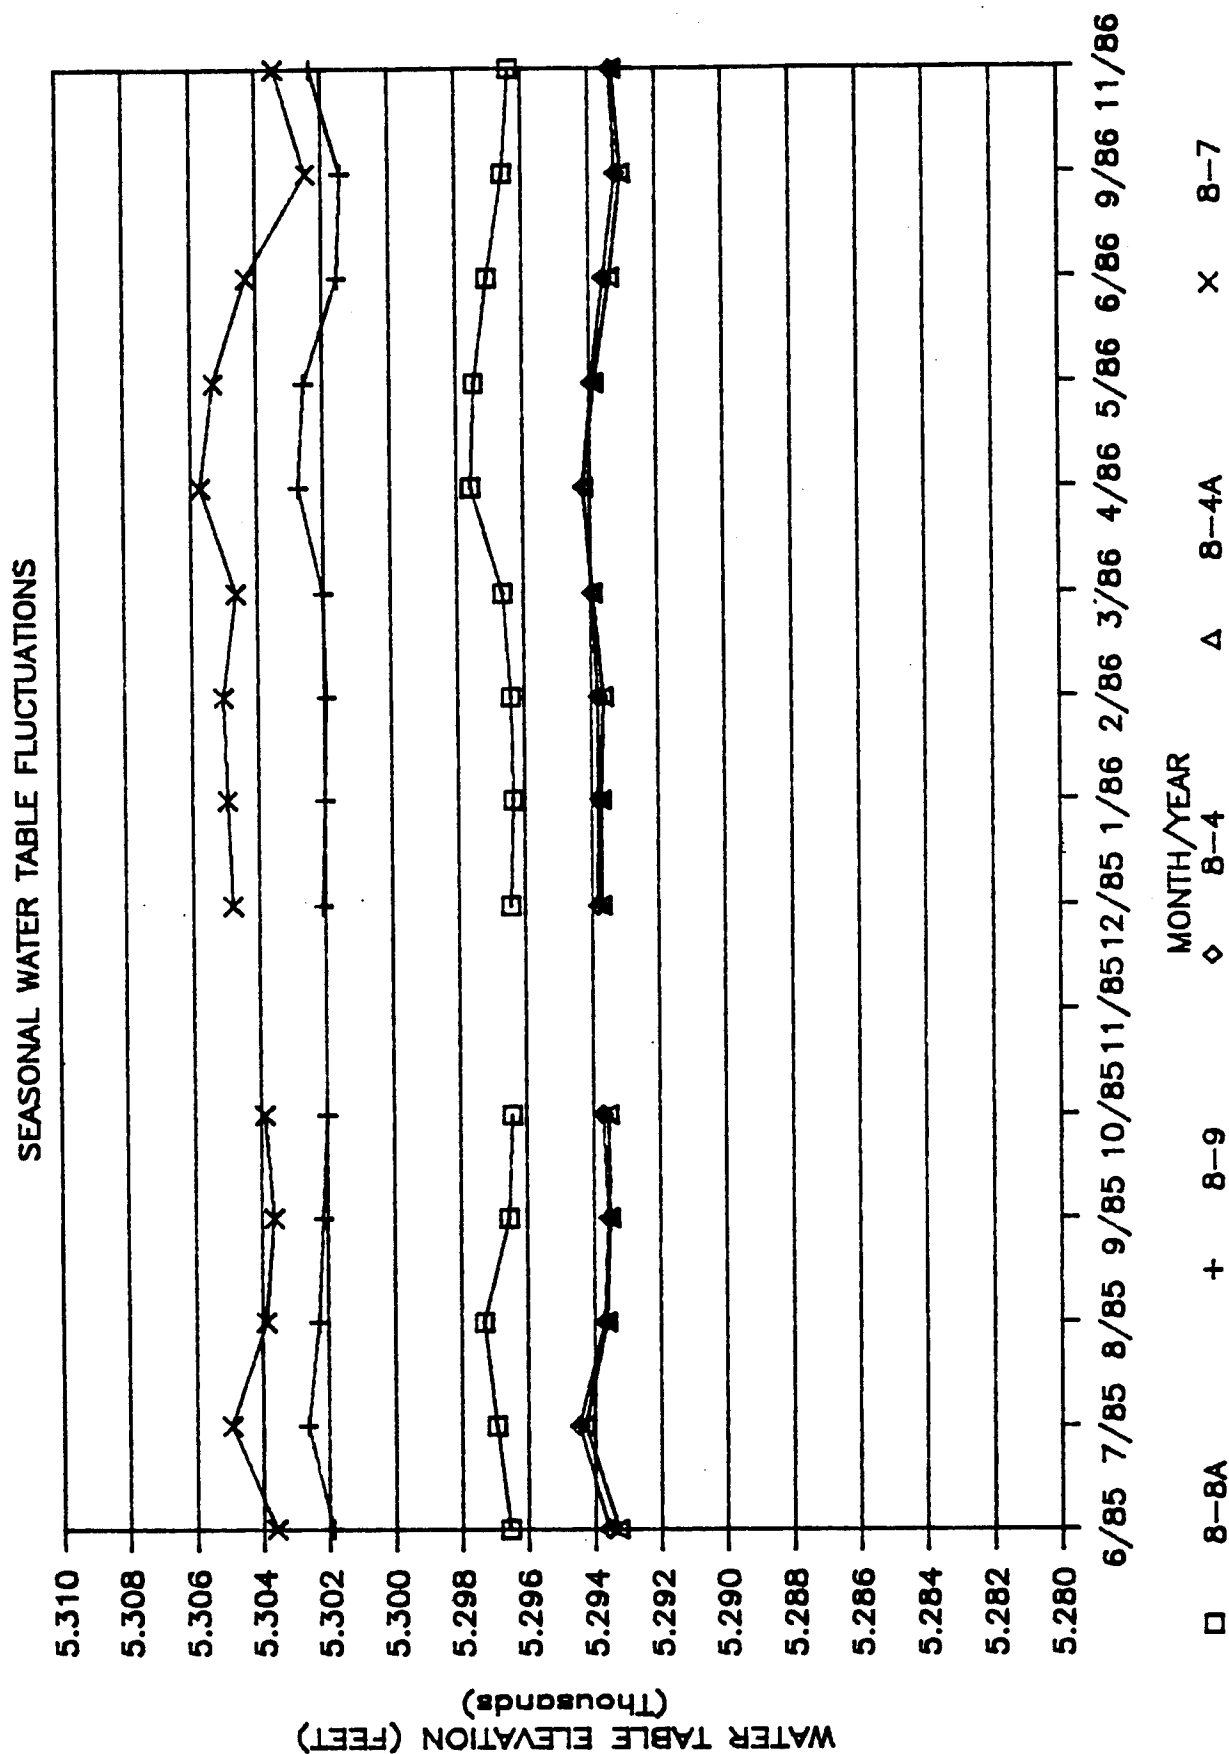
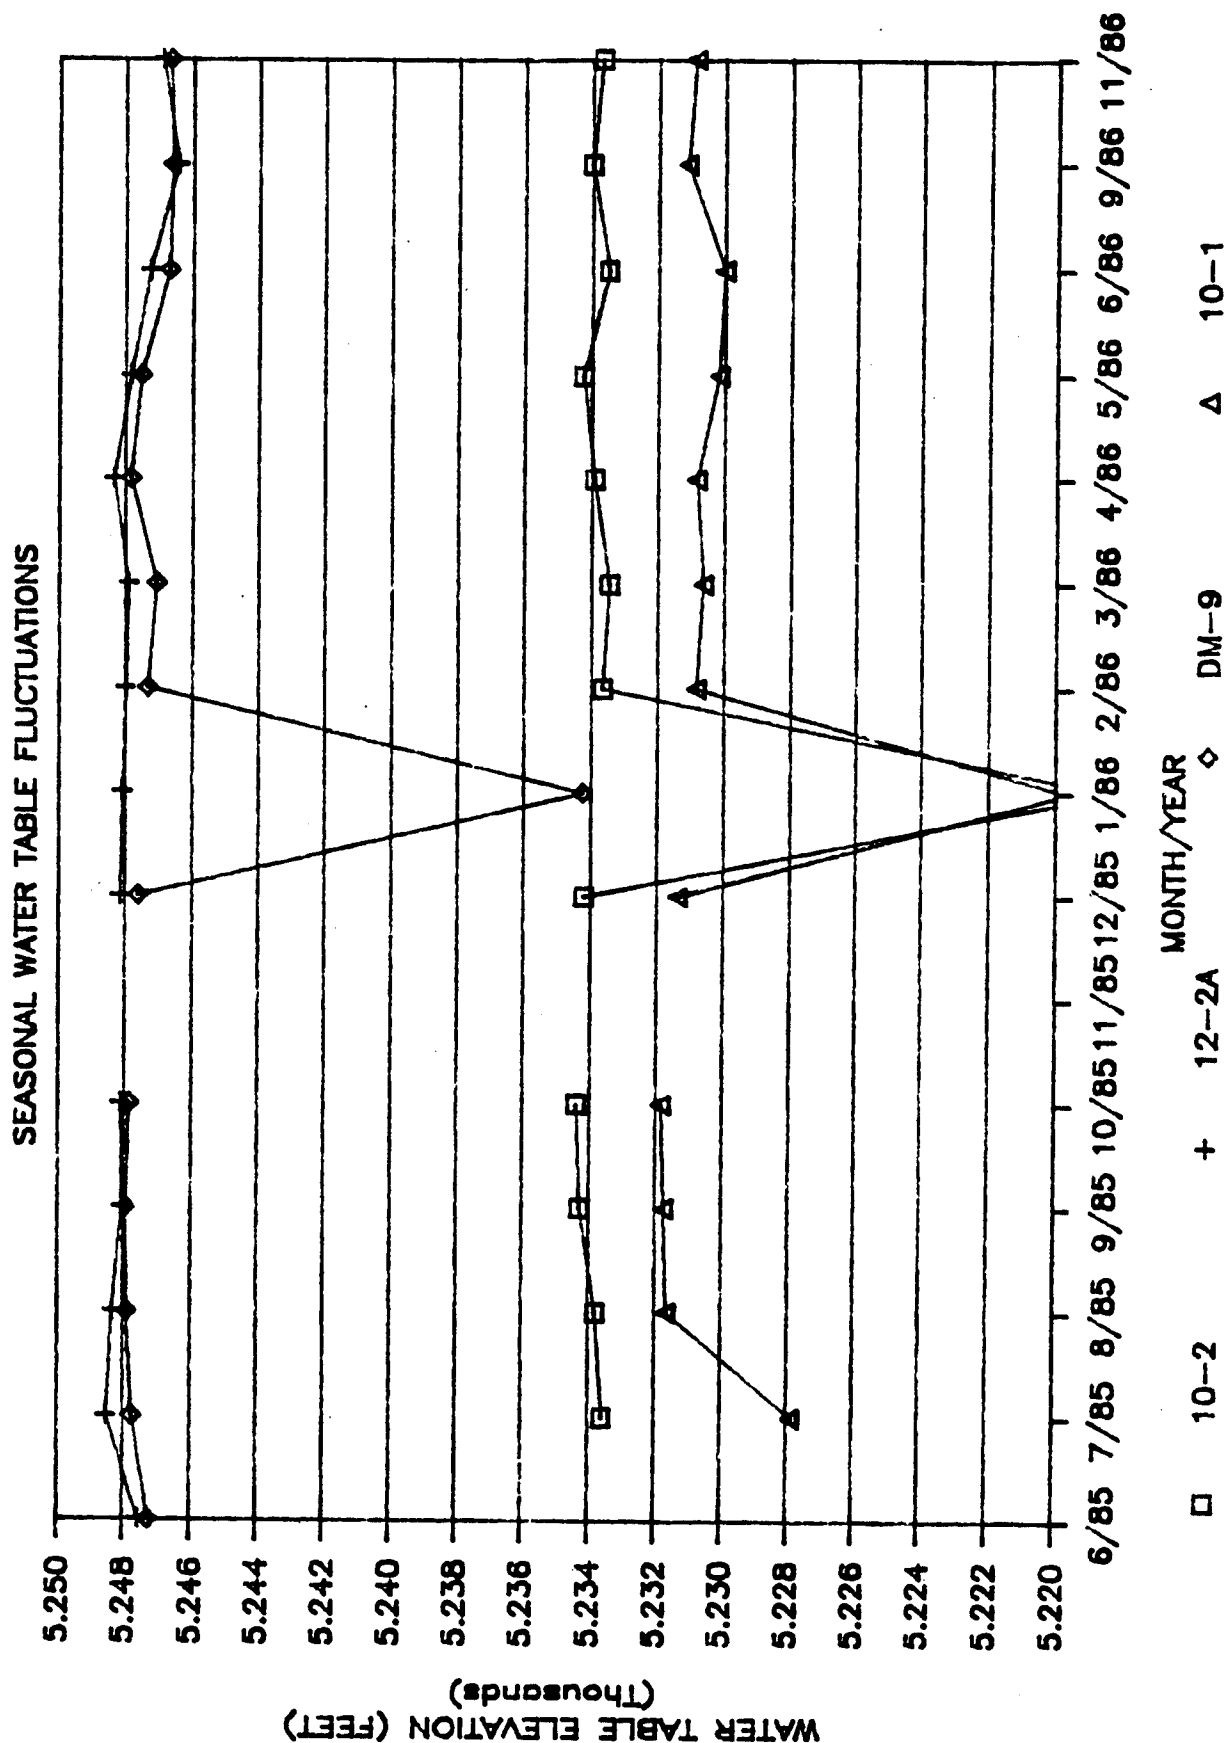
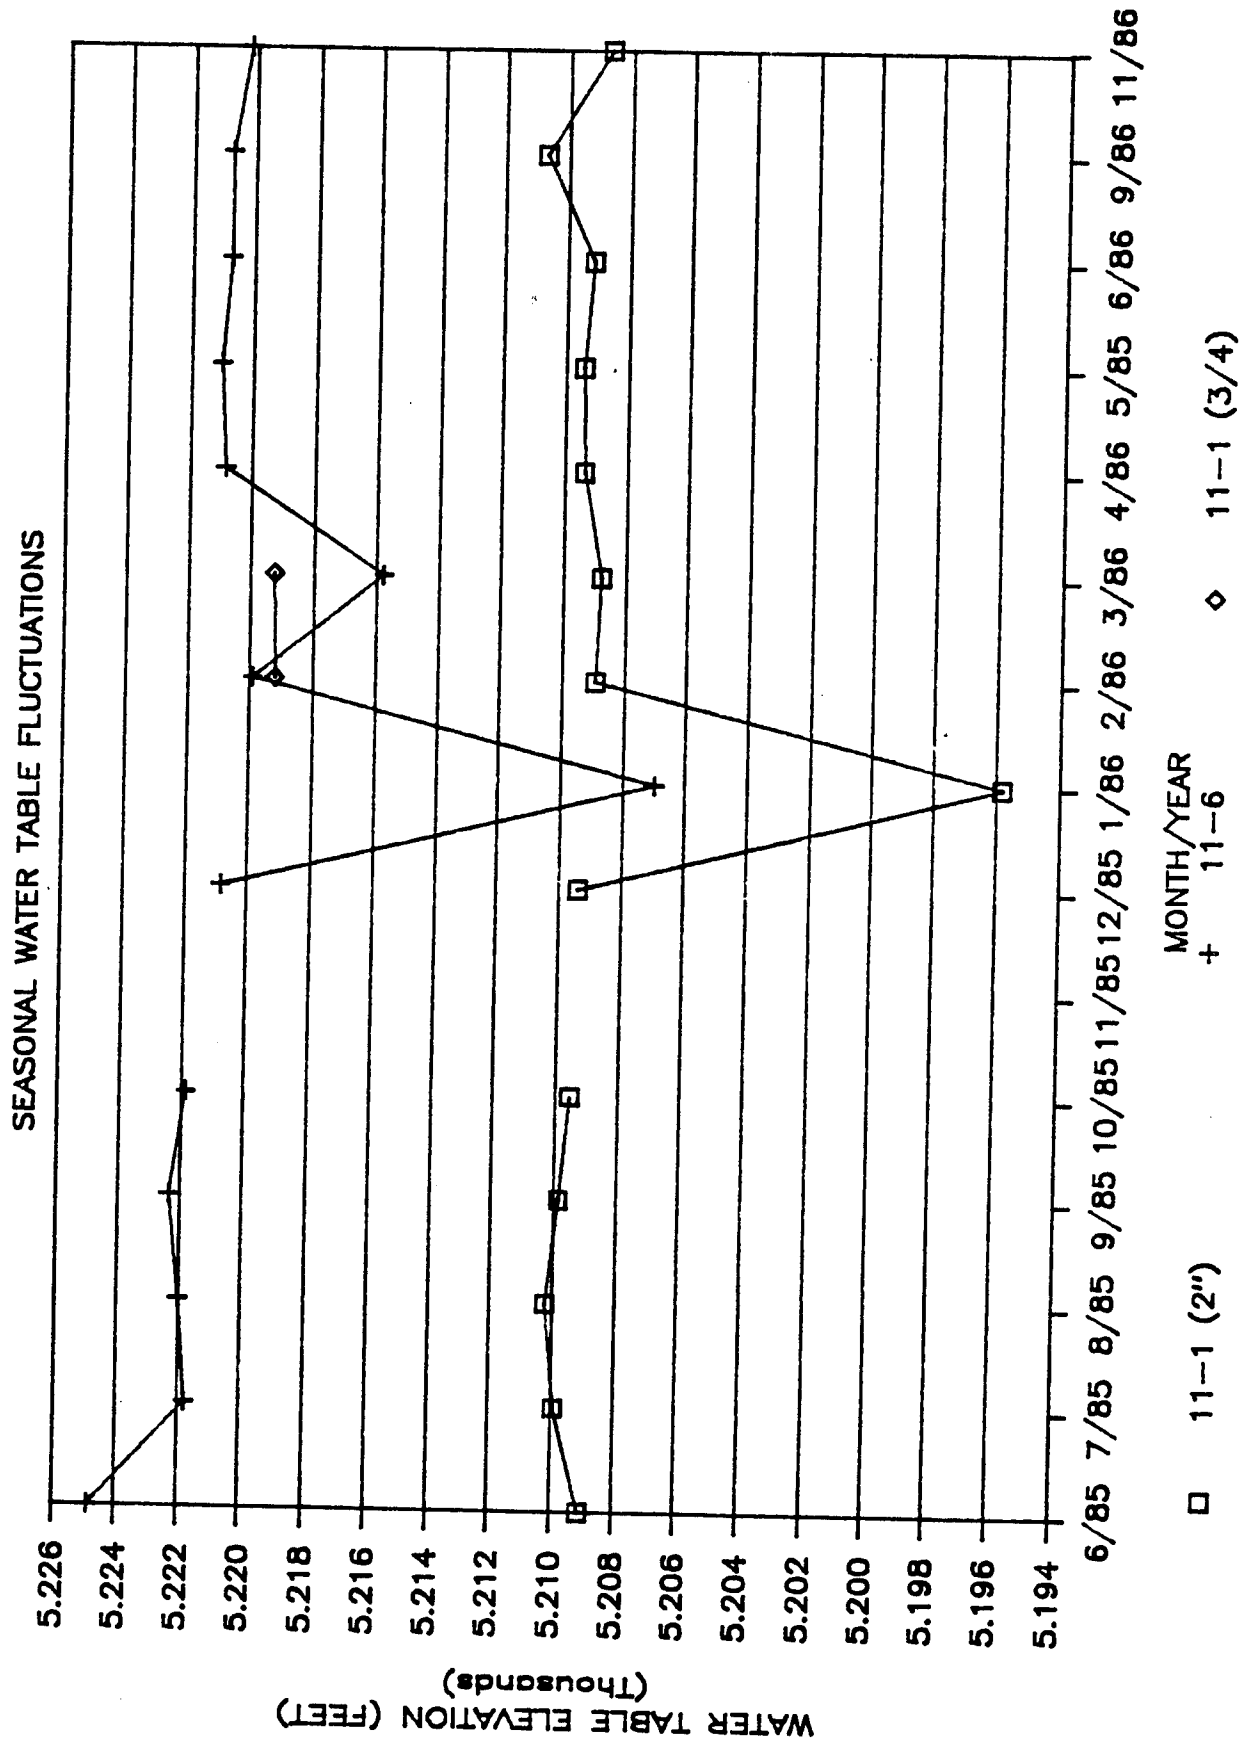
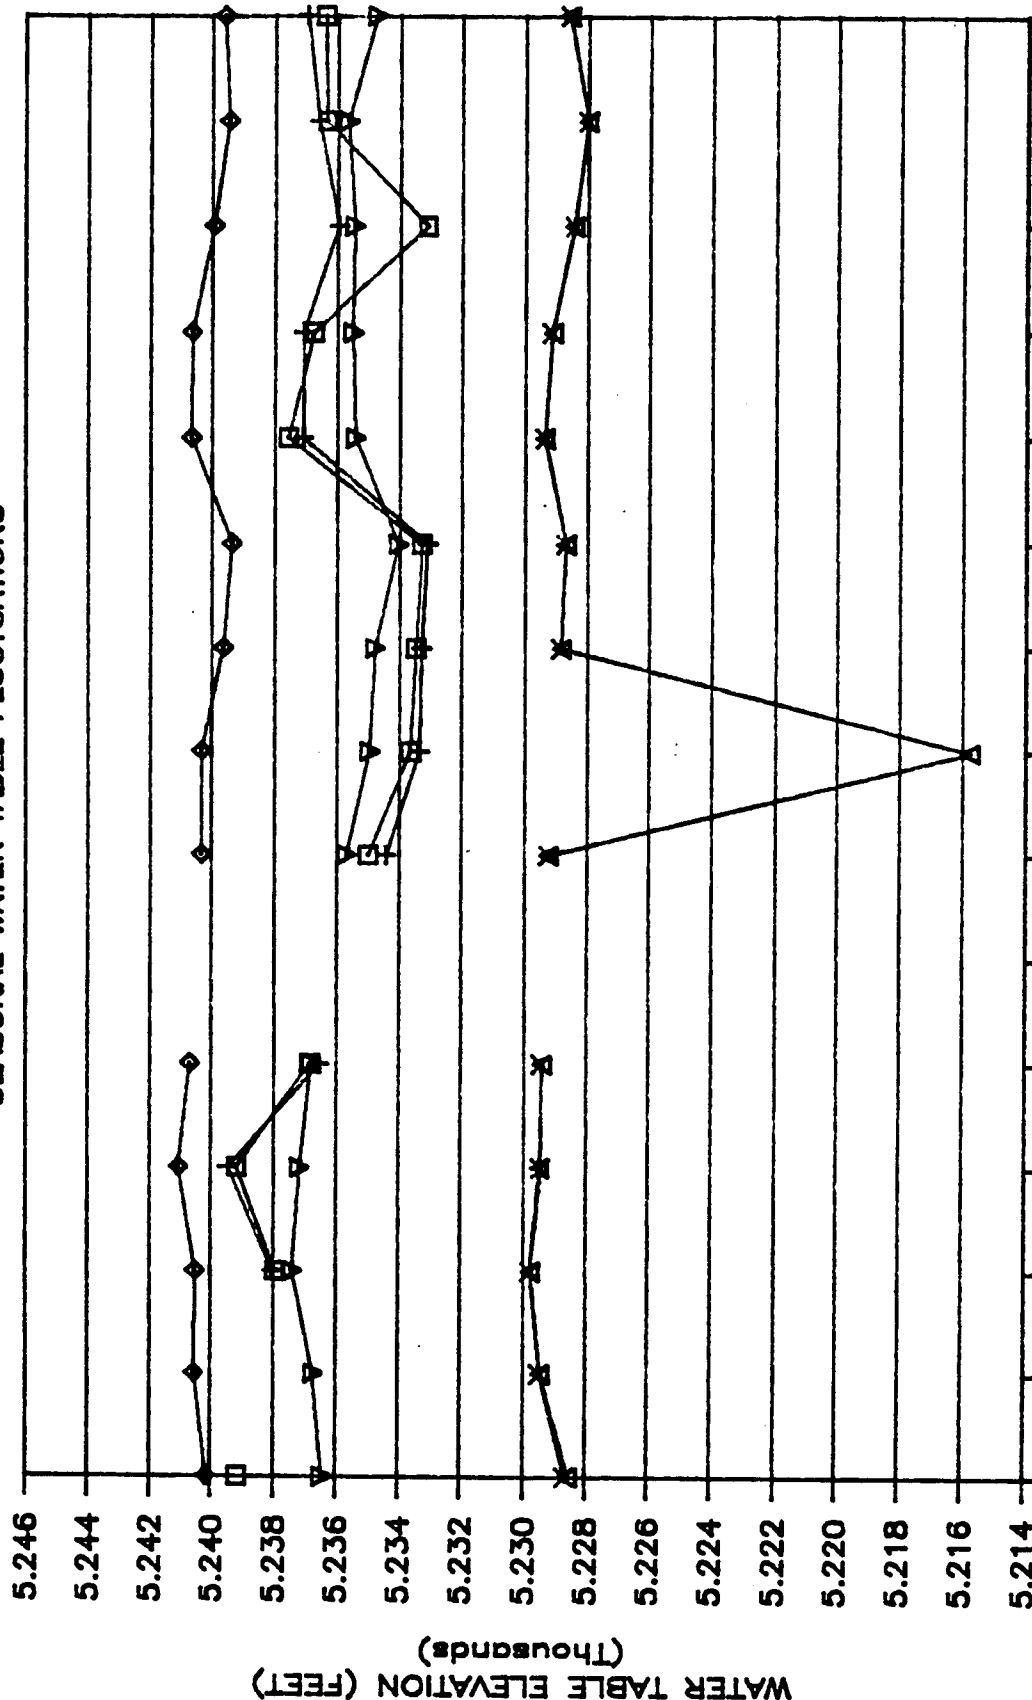
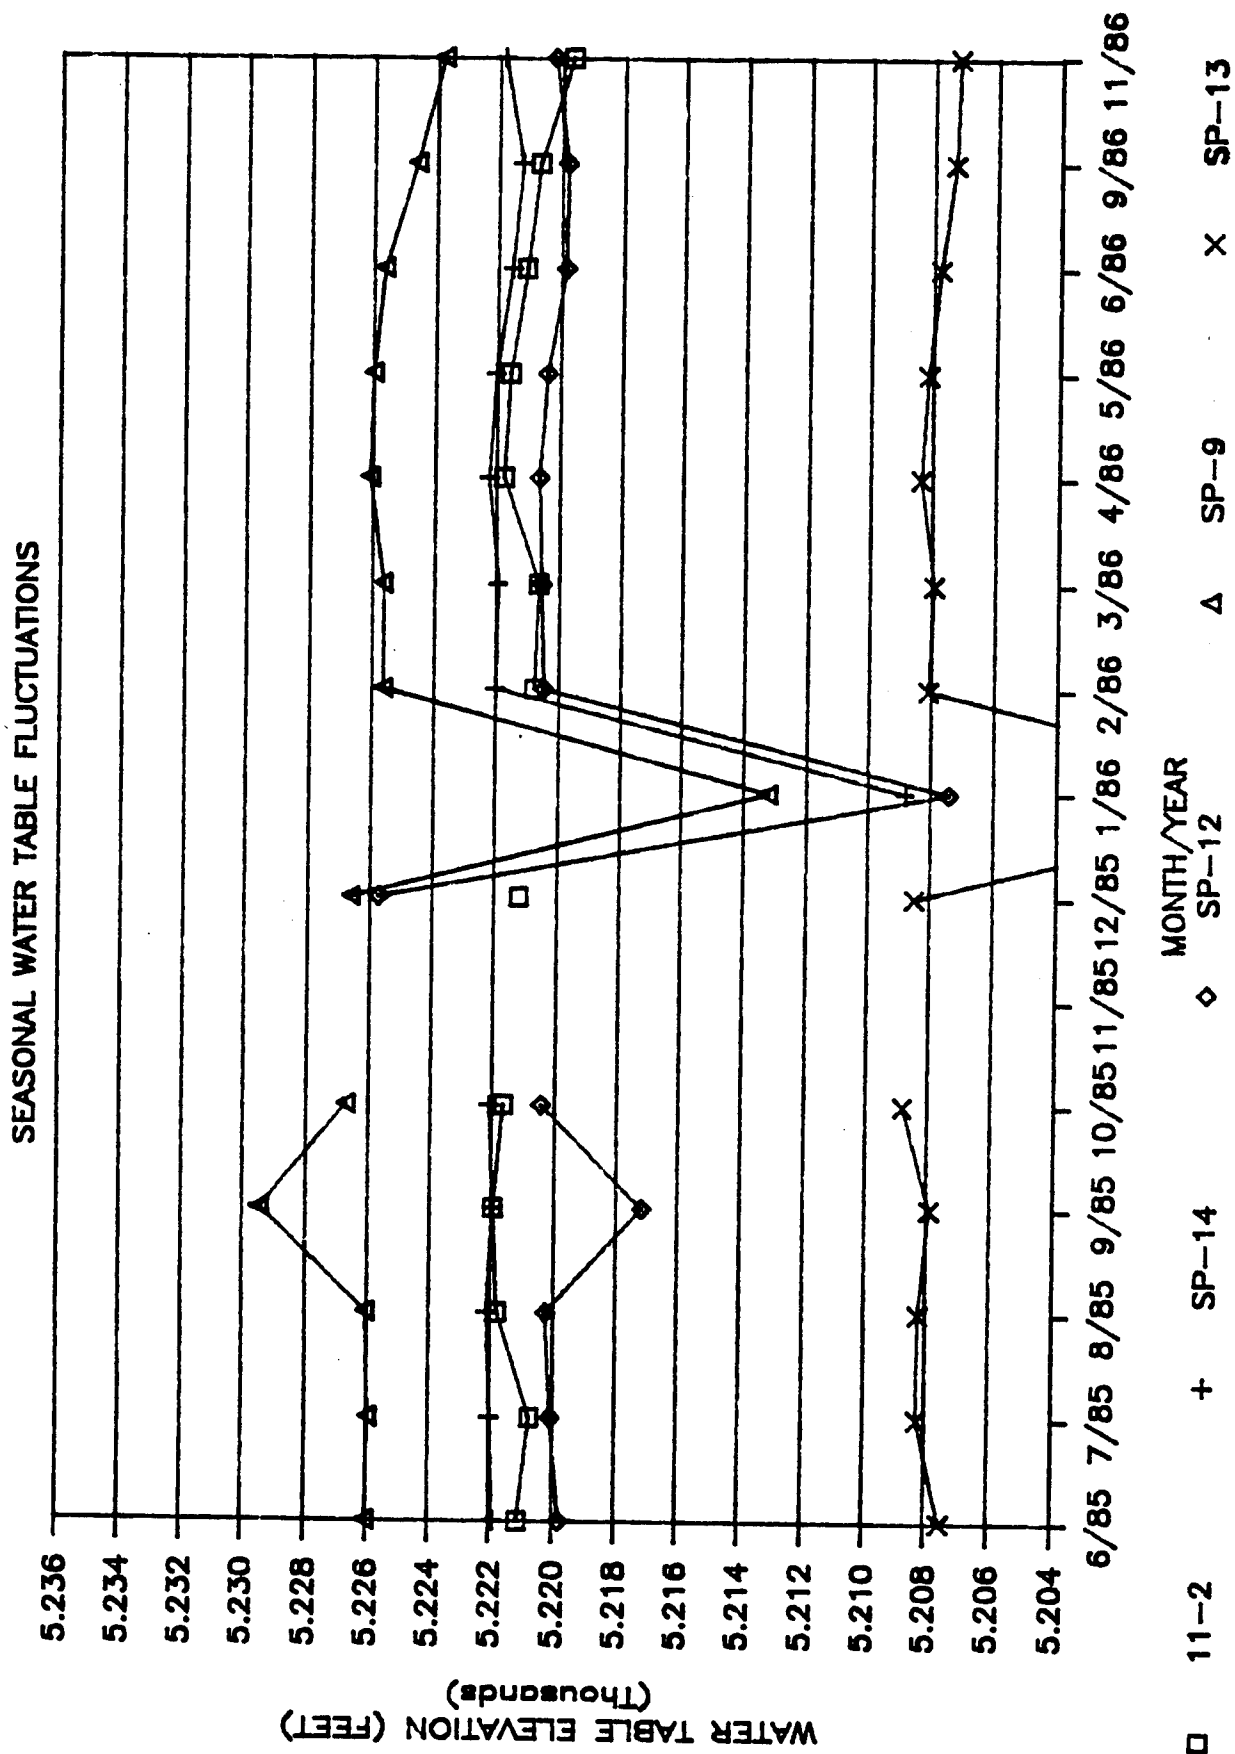
All data readings were considered to be good with the exception of some of the readings in January 1986. The January 1986 readings, as shown later in this report on the water table charts, were obviously in error. The cause of the readings being in error may have been due to the malfunction of the electronic measuring device.

As shown on Figures 4 through 15, the water table fluctuations were quite minor with most fluctuations less than two

(1) It is recommended that the monitoring program be continued only on a semi-annual basis until the design and construction of the runway proceeds.
